VOLUNTARY RECALL INTEGRATED SEAT POST CLAMP: KING PIN

Dedacciai has identified a potential safety issue involving the integrated seat post clamp **MODEL KING PIN** matching to the listed unpainted Dedacciai and Dedacciai Strada frame kits:

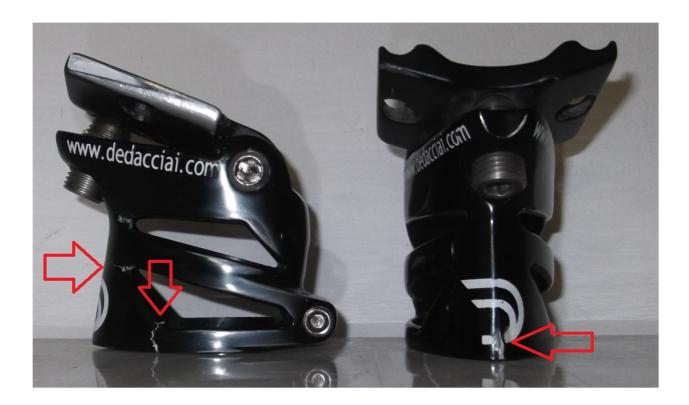
Under certain conditions it has been noticed the appearance of cracks in the KING PIN's frame mainly due to heavy utilization or extreme backward saddle positioning, as picture comparison:

If you notice the listed cracks on the back and on lateral body we kindly invite you to quit the bicycle utilization as the KING PIN can crack and eventually break during normal use, that may cause the rider to lose control, fall and suffer potentially serious injuries.

As a precaution, Dedacciai is voluntarily recalling all the KING PIN old model item – article code MRS360SSC - sold from the 1^{st} February 2011 till the 31^{st} March 2014 and replacing with the KING PIN NEW MODEL. The model comparison is listed in the below image:

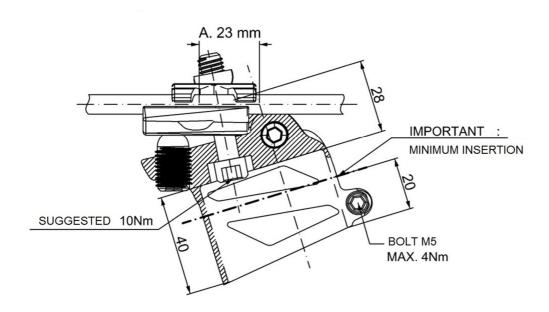
However during the integrated seat clamp assembling operations we recommend to follow the tightening torque ratio as shown in the below picture.

When the new KING PIN will be replaced we suggest to equip it by an official Dedacciai service and carefully read the listed assembling manual which can be also downloaded in the website www.dedacciaistrada.com and www.dedacciai.com > VOLUNTARY KING PIN RECALL
